**SUSQUEHANNA RIVER BASIN
WOLCOTT CREEK, BRADFORD COUNTY**

MACHAM DAM

(NDI I.D. ~~PA~~ PA-00043

**PHASE I INSPECTION REPORT,
NATIONAL DAM INSPECTION PROGRAM**

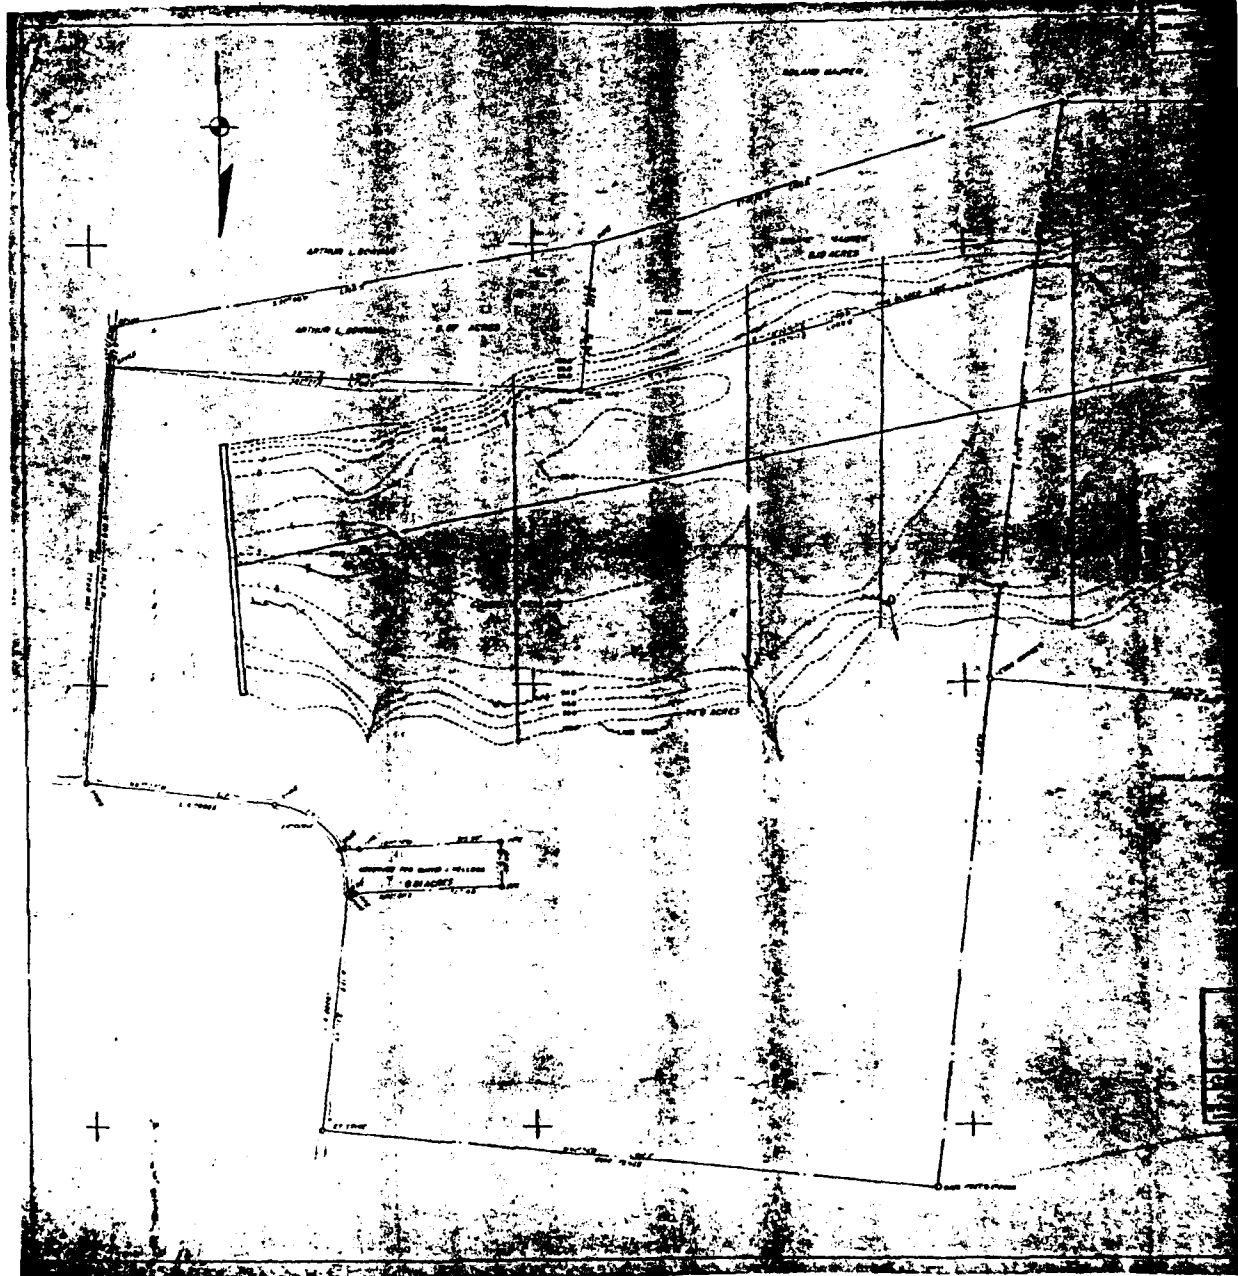
FIGURE 2
DOWNSTREAM CHANNEL MAP

Two potential centers of damage were investigated in the analysis. The primary area of concern is at Section 6 (see Figure 2), about 5.4 miles downstream from the dam, where a trailer park is located. At this section, the peak water surface elevations corresponding to the maximum section-minimum fail time scheme and the average breach scheme were approximately 3.4 feet and 1.8 feet above the non-breach elevations, respectively, and well above the damage level of the trailers (see Appendix D, Sheet 19).

Another potential center of damage is located at Section 2 (Figure 2), about 3,560 feet downstream from Macham Dam. The nearby residences were found to be well above the maximum levels of the breach outflows. However, a dairy barn was inundated by depths of up to 2.4 feet under the maximum section-minimum fail time scheme, indicating the potential for some property damage should the dam fail (Appendix D, Sheet 19).
